Damage is caused to Atlas IT (UTP05) by inserting RJ11 plug instead of RJ45

Atlas IT Network Cable Analyser
Model UTP05

PEAK®
electronic design ltd

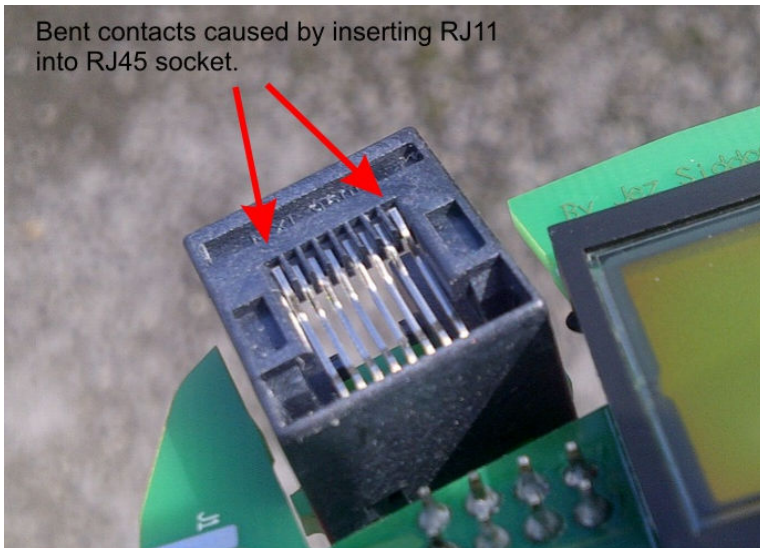
Bent contacts caused by inserting RJ11 into RJ45 socket.

Result on screen:

```
Term+12345678
Atlas+×234567×    ↓
```

This instrument is ONLY suitable for RJ45 plugs. This is confirmed on the front panel of your instrument.

Under no circumstances must any other type of connector be used, even if it seems to fit.

In particular, use of telephone style RJ11 connectors <u>WILL</u> damage the instrument socket and the terminator socket permanently, leading to intermittent faulty readings that you can't rely on.

We want you to have trouble-free use of your instrument, please ensure you only test RJ45 connectors.
